The 1st International Scientific Conference on Environment and Sustainble Development (ISCESD 2013)29-30 Dec,2013

Evaluation of the Performance of the Aerated Grit Chambers Under No Maintenance Condition

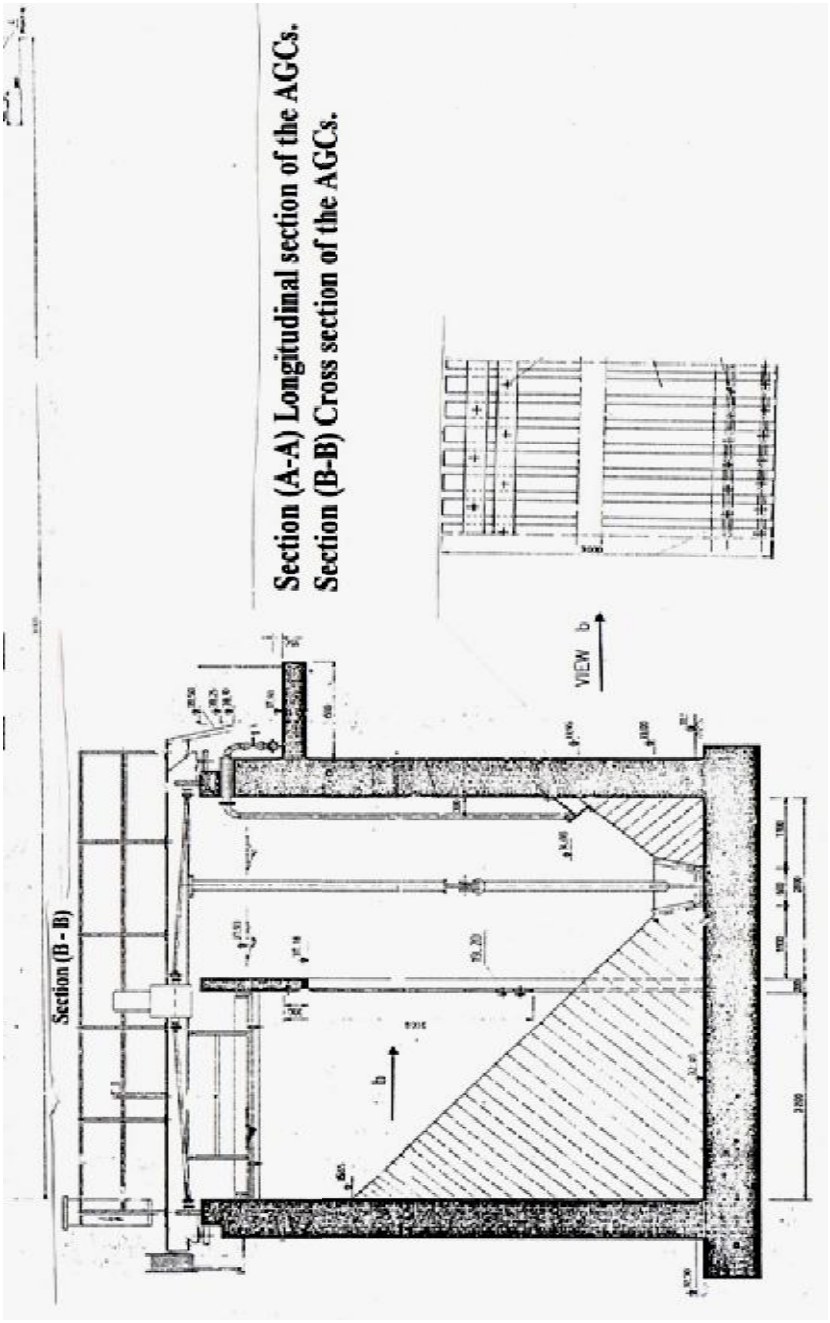
Figure.(2) Cross sections of the AGCs.

In 1967, Albrecht [(4)] described a satisfactory method for hydraulic control of conventional AGCs. The installation of a vertical baffle agrees with the requirements of hydraulic controlling in the region of the collector. It is noted that the vertical baffle enable concentrations of the air lift pumping action in the region of the collector. The resultant circulation patterns is illustrated in Fig.(2).

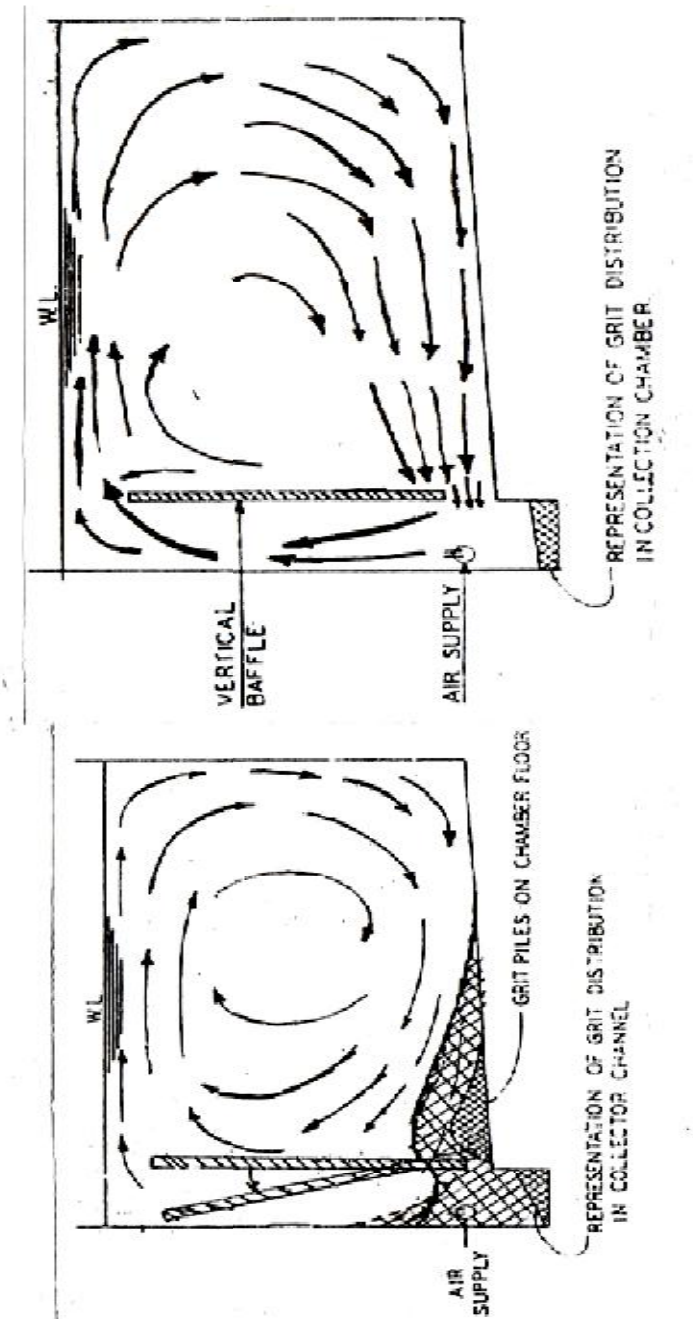
Figure.(3) The resultant Circulation Pattern in AGCs.

The collapsing of the longitudinal baffle interacted with some failures in screening units and aeration equipments (due to insufficient maintenance for the AGCs), all of these caused the case study problem. Fig.(3) is a sketch of an AGC, and the arrows indicate the circulation patterns just before the occurrence of the problem under study. This location was actually noted as seen visually in a dewatered AGC plate (1) through plate (4).

Abnormal accumulations of sand, grit, plastic, etc., insufficient screening of incoming sewage from screen units gave rise to the case study problem at hand, which resulted in the failure of the installed vertical baffle. The grit mounds up and thus clogging the opening under the vertical baffle. Accumulation of grit piles up causing an abnormal lateral load upon the vertical baffle, columns, causing them to collapse.

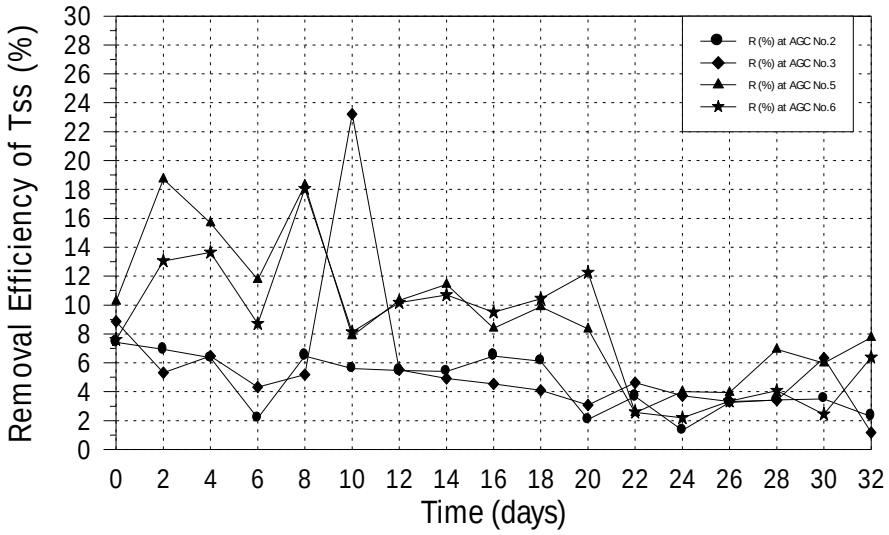
Figure. (4) The Removal Efficiency of Tss across AGC (No. 2, 3, 5 and 6) during 18 Aug-19 Sep.

From Fig. (4) and Fig. (5), it could be observed that for the four AGCs, the removal efficiency of Tss ranged between (4.005-8.404)% as shown in Table (3). It is clear that this was due to the presence of high accumulation of grit inside the AGCs, which almost tended to re-suspended.

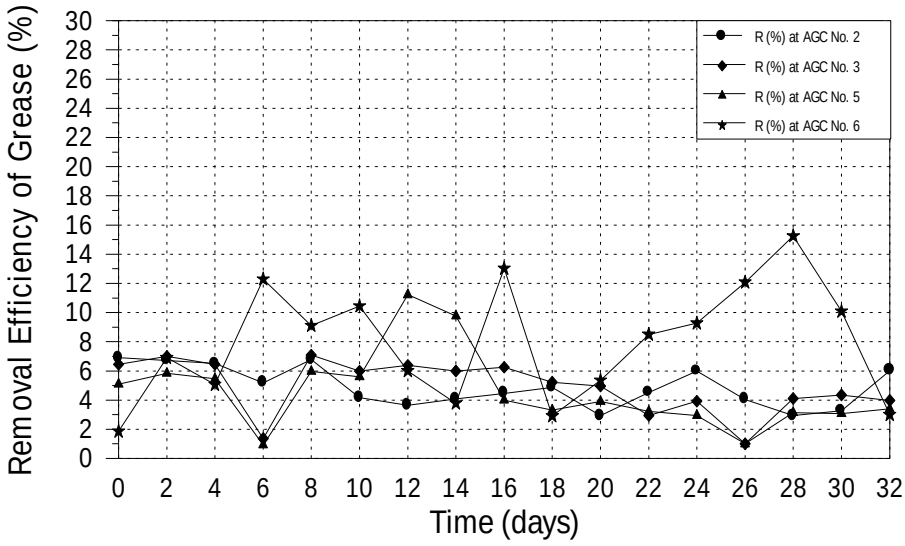
Figure.(5) The Removal Efficiency of Grease across AGC (No. 2, 3, 5 and 6) during 18 Aug-19 Sep.

From Table (4), it could be observed that the removal efficiency of grease ranged between (3.840-5.890)%. These low values were due to the fact that the skimmers which sweep the accumulated floatable matter over the sewage surface were out of service for along periods of time causing unpermitted accumulations especially at the corners of the AGCs and near the outlet zone of the AGCs.

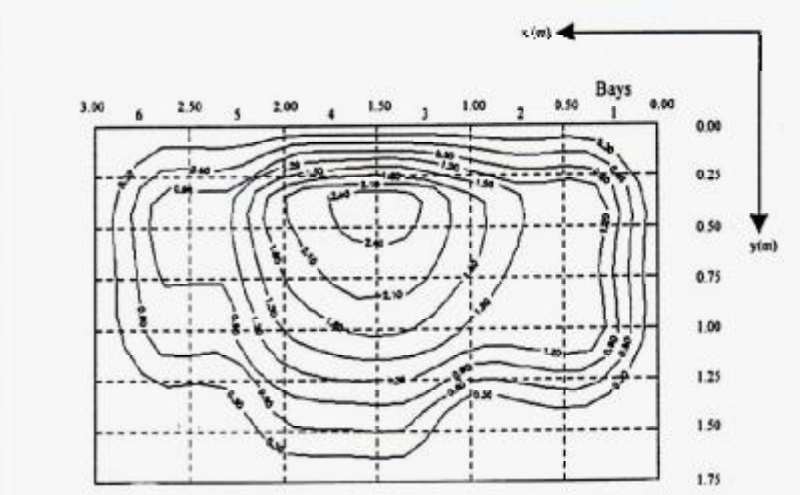
Figure.(6) Velocity Distribution across the section (1) of the AGC(No.6)

At section (1), in Fig.(6), it could be observed that, there is only one large cell of high-velocity located in the top parts of bays 3 and 4 with some uniform

velocity region near the surface due to the fact that this section is located at the inlet zone of the AGC (No.6). The magnitude in this high-velocity cell became smaller and it increased in size and spread to include parts of bays (3, 4, and 5) of section (2) as shown in Fig.(7). Fig.(7) shows that at section (2) there is a small area or cell of high-velocity in bay (4). A second cell with a smaller velocity is located in bays (7 and 8).At section (3), Fig.(8), there is a small region of high velocity in bays (3 and 4) with a smaller cell of low velocity located in bay (10).At section (4), Fig.(9), there is only one small high velocity area in bays (6, 7 and 8). This high velocity region has enlarged in area with reduction in magnitude when compared with sections (2) and (3).In general, it could be observed that there were large areas of dead spaces for the three sections especially in bays (10, 11, and 12). These bays are located in the region of the degritter where the longitudinal baffle collapsed and were due to absence of aeration along the tank length that could have provided a helical flow of the fluid body. In general, for the whole four sections, it could be observed that the depths of the flow ranged between (1.75-2.00) m, which meant that the accumulation of grit level inside the tank reached (4.00-4.25) m. This accumulation should not be permitted at all, because it decreases the grit removal and tends to resuspend settled solids in the bottom of the chamber. It is worth mentioning that the ill-distribution of the velocity currents of the flow is the result of the bad maintenance which is also the result of the stoppage of the operation of the grit removing system. Had the grit removing system been working, in the opinion of the writer, all these problems could have been avoided. No collapsing of the longitudinal baffle and no accumulation of grit could have been possible if the degritting system was operating. One important fact which was observed by the writer, was the septicity problems which was the results of the failure of the above mentioned degritting system coupled with the non-operating aeration system. In the writer opinion, septicity problem could be alleviated if the aeration systems, degritting systems, and longitudinal baffles are reinstalled as designed.
